Intel[®] Celeron[®] Processor Specification Update

Release Date: September 2002

Document Number: 243748-047

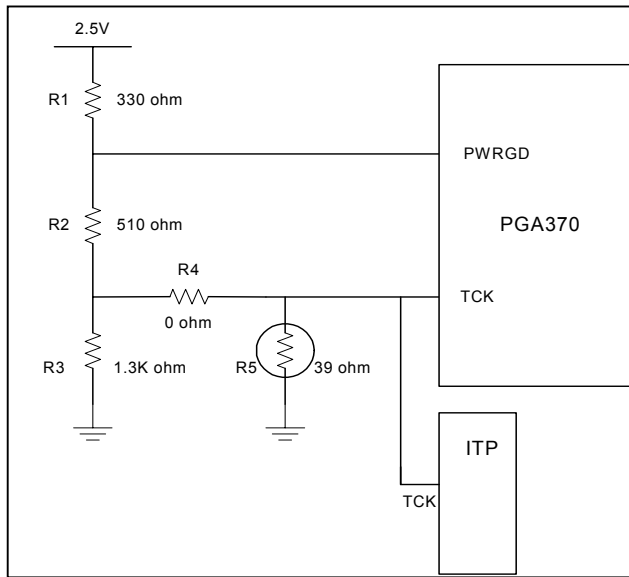
Figure 1 Celeron® on 0.13 Micron Processor 256K Platforms Workaround

In addition, the example workaround circuits shown do not support production motherboard test methodologies that require the use of the processor JTAG/TAP port. Alternative workaround solutions must be found if such test capability is required.

For Production Boards:
Depopulate R5

To use ITP:
Install R5, Depopulate R4
