Intel Celeron™ Processor Specification Update

Release Date: April 15, 1998

Order Number: 243748-001

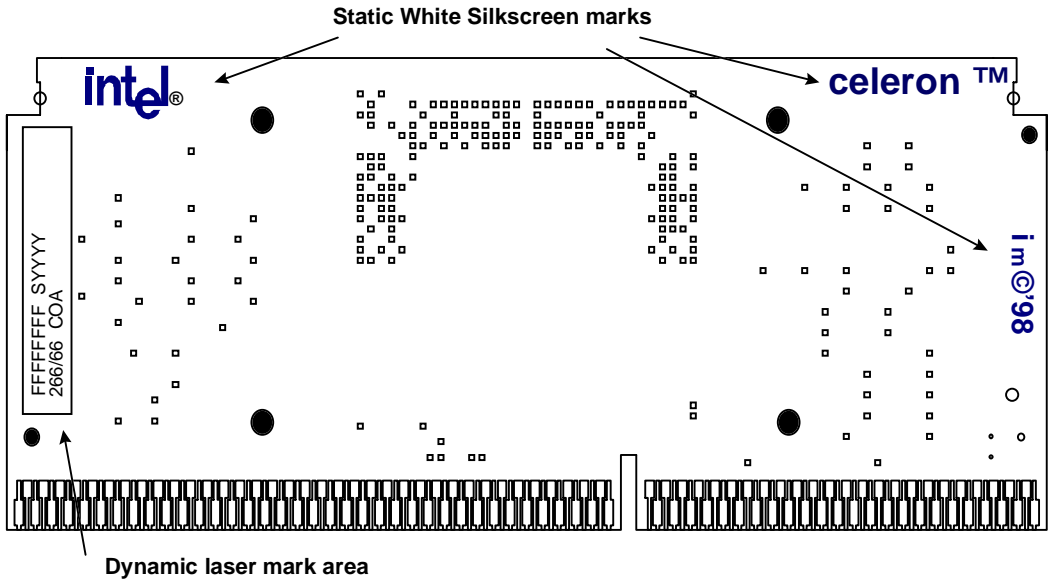
Intel Celeron™ Processor Markings

NOTES:

- SYYYY = S-spec Number.
- FFFFFFFF = FPO # (Test Lot Traceability #).
- COA = Country of Assembly.
